# **Motor-Generator Vibration Problems Encountered When Restaging an FCCU Turboexpander**

by  
Fred R. Szenasi  
Engineering Dynamics Incorporated

This paper describes the solution of a vibration problem which resulted from the conversion of a single-stage power-recovery turbo expander train in an FCCU to a two-stage turbo expander. Details of the equipment train and operating speeds are given in Figure 1. During the start up of the upgraded expander train, high vibrations (in excess of 10 mils peak-peak) were experienced by the motor-generator. These high vibrations caused the unit to shut down as soon as it reached rated speed.

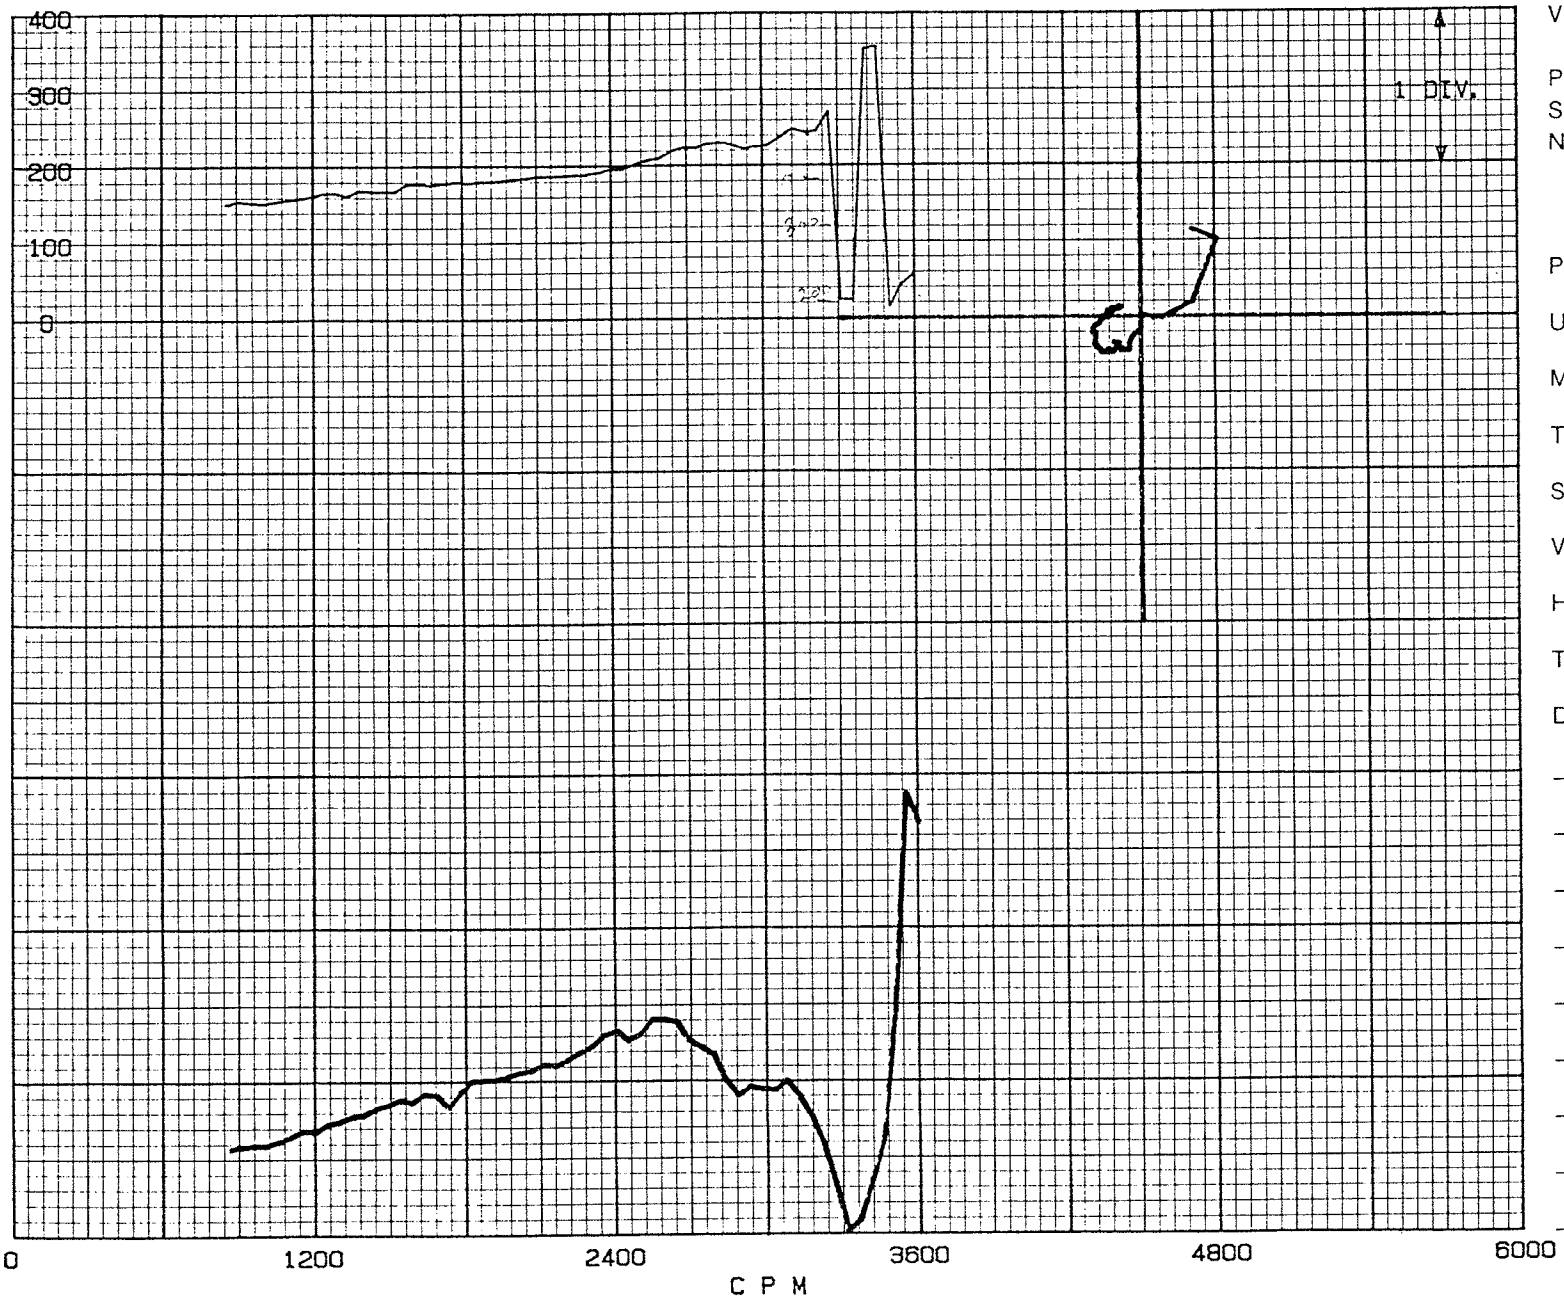
Figure 6b

TEST PT MIB-VERTICAL

SPEED STARTUP

The high vibration levels of the motor-generator were determined to be caused by a lateral critical speed near the operating speed. Peak responses were measured at about 2600 rpm and 3550 rpm in the vertical direction and 2600, 3150, and near 3600 rpm in the horizontal direction (Figure 6). During the field testing, the critical speeds were found to be sensitive to the oil bearing temperature. On the basis of this sensitivity, the bearing clearance was increased and the oil temperature was increased to move the critical speed below operating speed. These changes are described in more detail in the following sections. This made the unit easier to balance so that it could be operated with acceptable vibration levels until the next planned outage. Meanwhile, analyses were continued in an effort to develop a permanent solution.

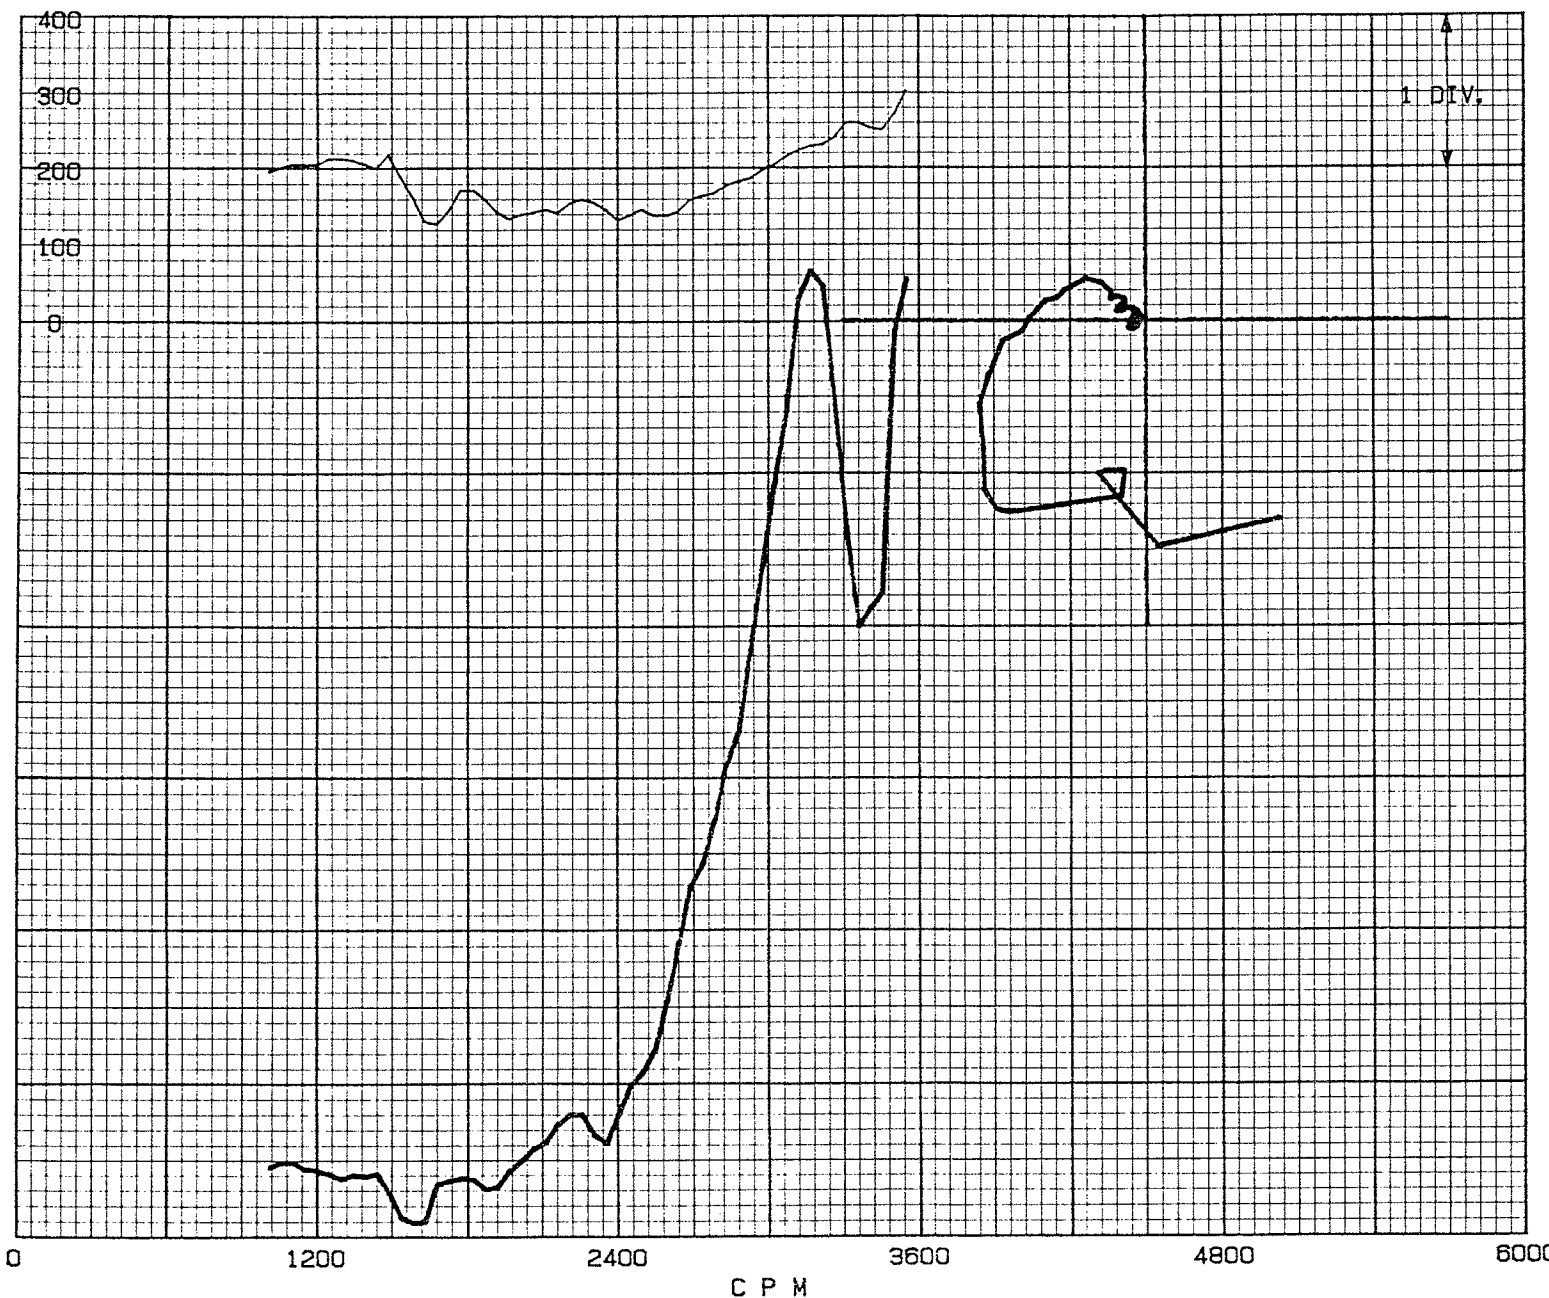
Figure 6c

TEST PT MOB-HORIZ

SPEED STARTUP

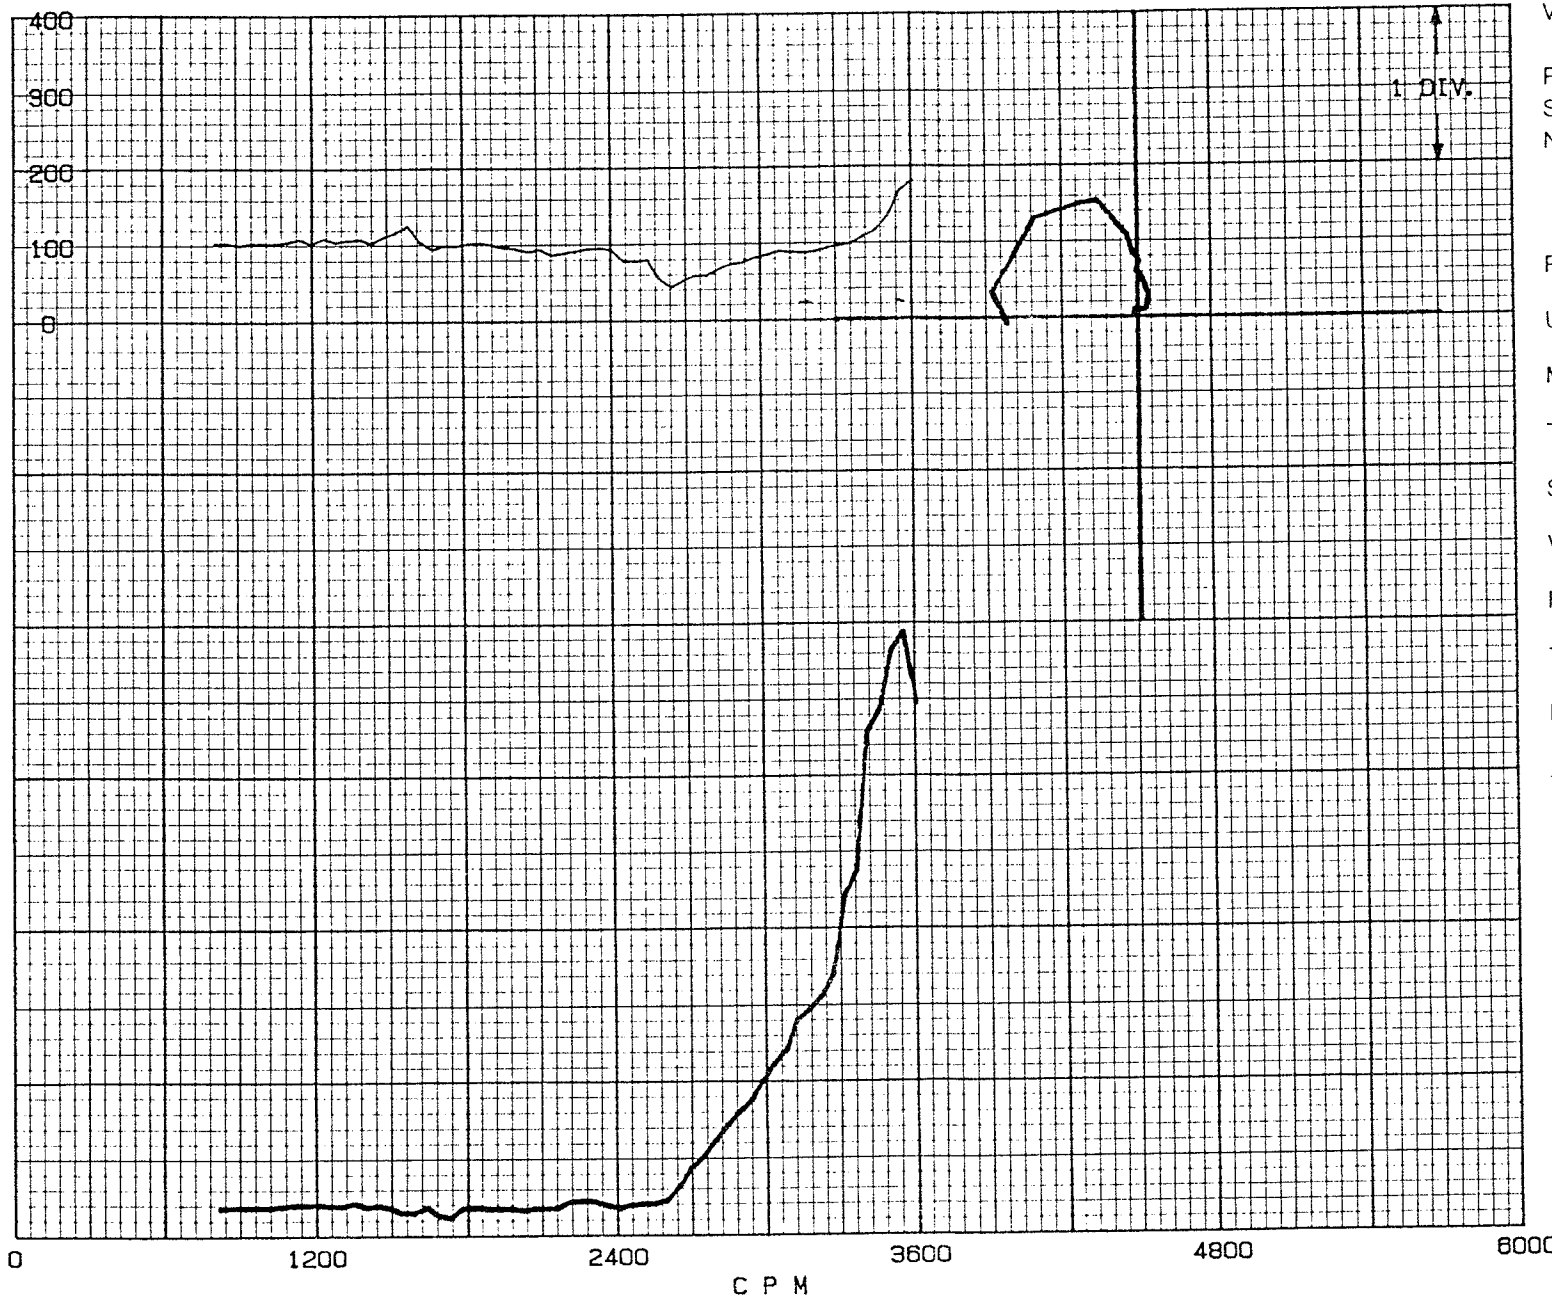
Figure 6d

PLANT \_\_\_\_\_  
UNIT 31-BL-1  
MACHINE MOTOR-GENERATOR  
TEST PT MOB-VERTICAL  
SPEED STARTUP  
VERT 2.5 MIL/DIV  
HORIZ 0 - 100 HZ  
TIME 2:00 PM  
DATE 10-23-85

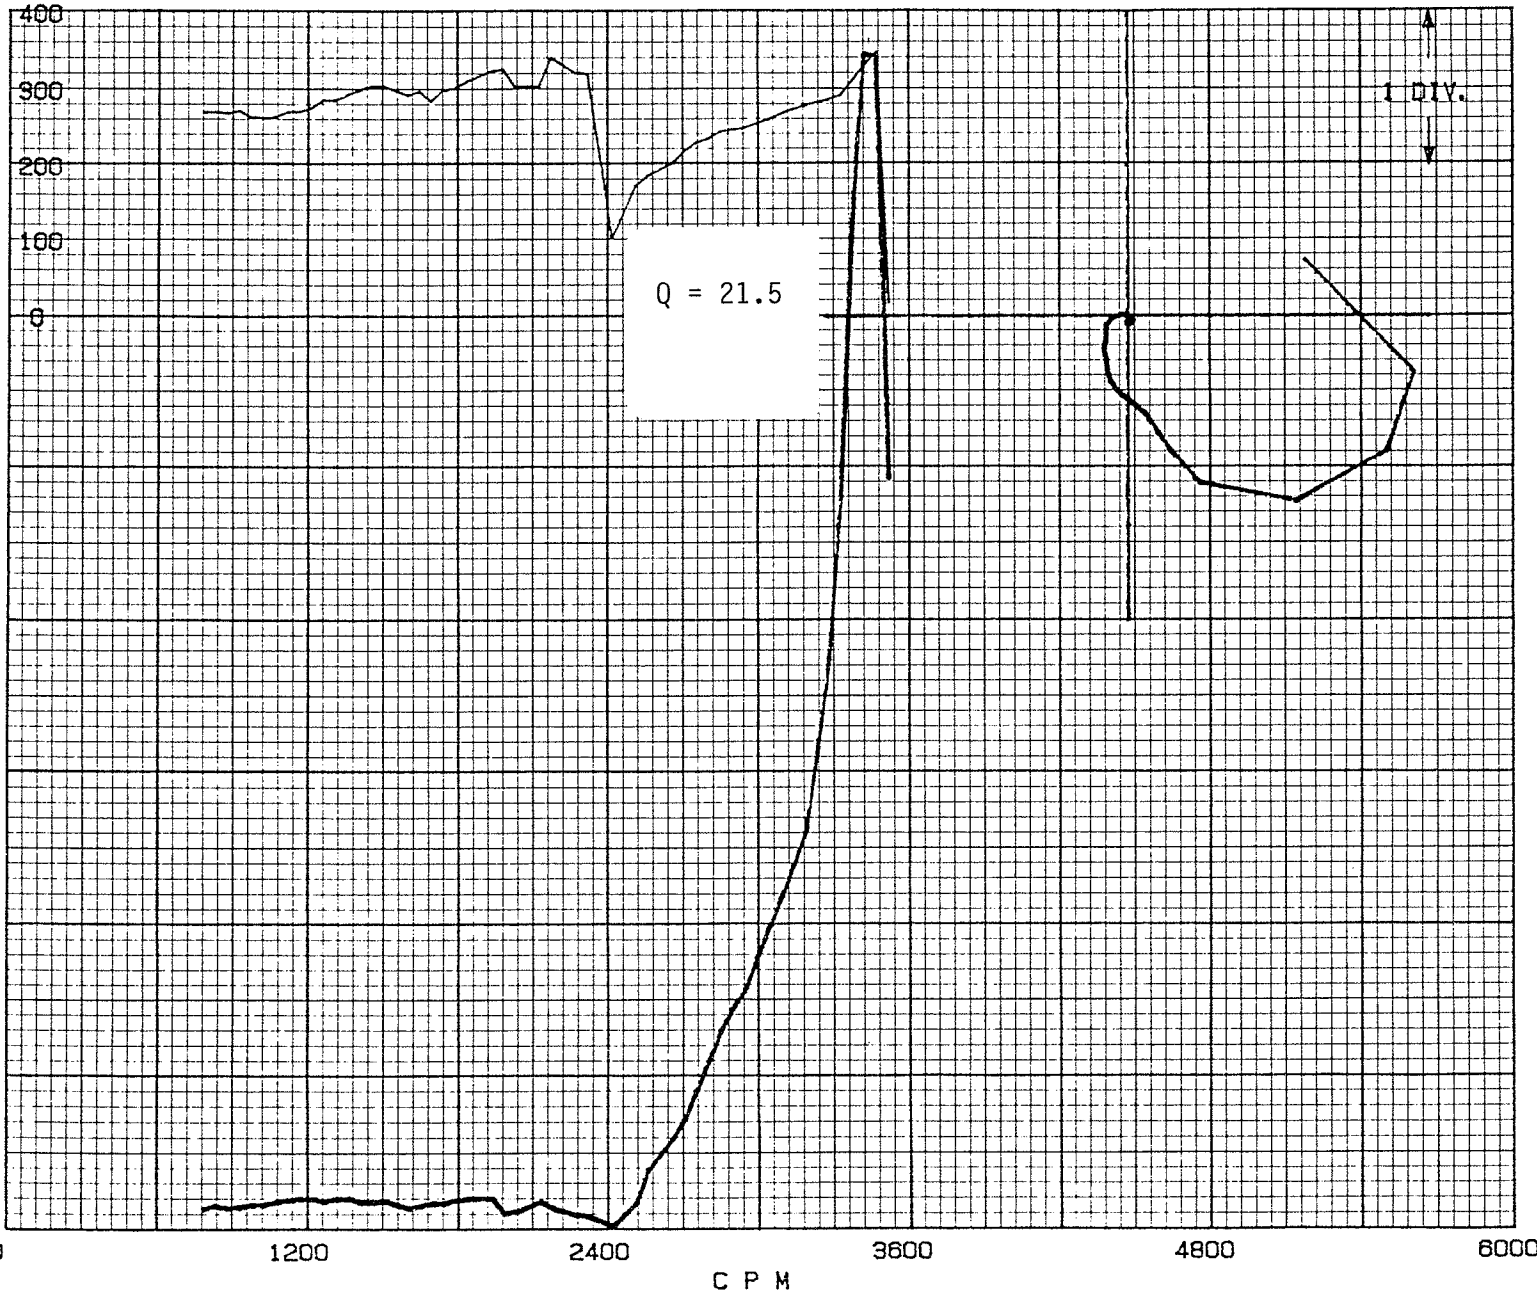
Figure 7

to lower the critical speed away from operating speed, the lube oil was warmed up to 120°F. The effect of the bearing oil temperature reduced the critical speed to 3450 rpm with an amplitude of 7.7 mils and an amplification factor of 21.5 (Figure 7). This sensitivity to bearing oil film stiffness indicated that the critical speed could also be affected by a change in the bearing clearance.

OIL TEMP = 120 DEG F.

BRG CL. DIM. 9 MILS

PL 1 29 GM/177 DEG

PL 3 38.5GM/318 DEG

The motor-generator manufacturer stated that the bearing clearance for this motor-generator could be increased to 15 mils. Larger clearance bearings were made and installed. The oil temperature was held within the range of 115 to 125°F maximum. The net effect of increasing the bearing clearance and increasing the oil temperature to 120°F resulted in lowering the critical speed to 3360 cpm, with an amplitude of 4 mils, and an amplification factor of 16. The results of the change in critical speed for the bearing clearance increase can be seen by comparing Figures 7 and 8. The vibration levels at the running speed of 3600 rpm were less than 2 mils peak-peak.
